FERNALD FACT SHEET ~ SILOS 1 AND 2

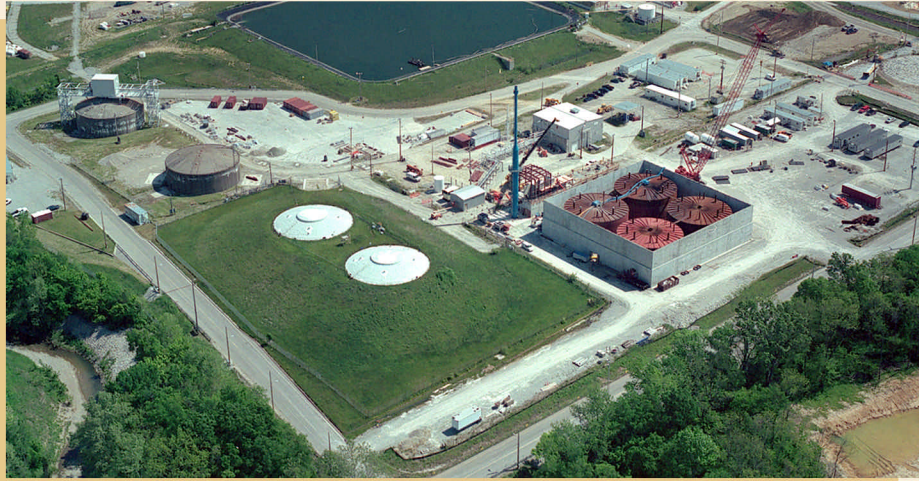
PHOTO: Silos 1 and 2 (white tops) contain waste generated during ore refinement (7792-153).

Over the years, Fernald has used many engineering techniques to strengthen Silos 1 and 2 and reduce radon emissions until final disposition. In 1963, crews constructed an earthen berm around the silos. Workers sealed the vents in the domes in 1979 and expanded the berm in 1983. To comply with stricter environmental regulations, workers installed covers over the center dome sections in 1986 and added a polyurethane coating in 1987. Crews also capped the waste with bentonite clay in 1991 and patched and sealed the domes in 1999.
